Manhole Inspection Summary

Manhole # S31SS_002MH

Insp Date: **5/10/07 11:39 AM**

Location Address: **310 FOX ST**

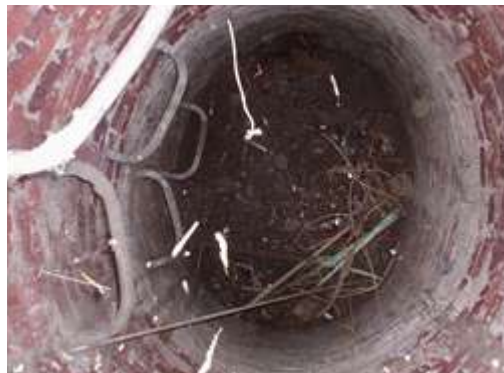
Top View

Corroded steps. Channel debris.

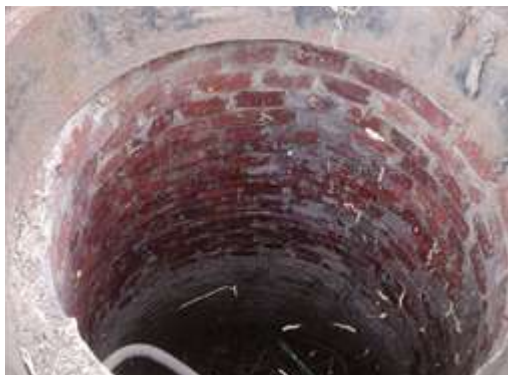
Defect

Frame leaks. Frame offset. Adjustment deterioration and infiltration. Barrel infiltration.

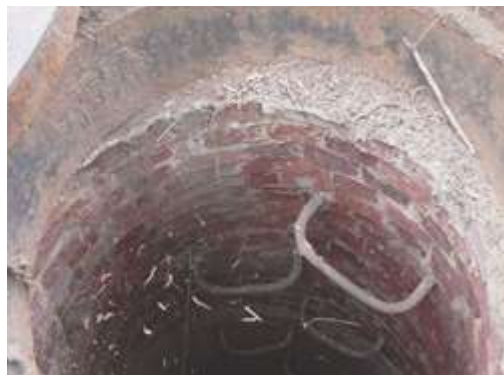
Defect

Frame leaks. Frame offset. Adjustment deterioration and infiltration.

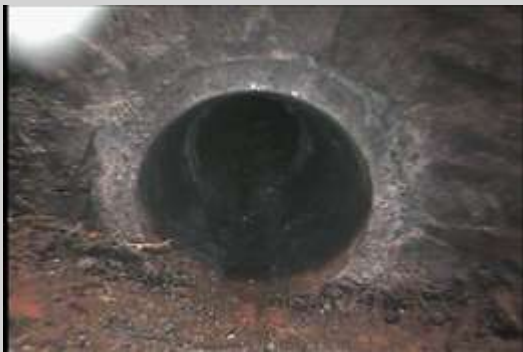
8 in. Circular Gravity Sewer
Pipe Out @ 12 O'Clock

Deposits: ☐ None ☒ **Mud** ☐ Sludge ☒ **Debris** ☐ Grease

Silt Depth: **0** (in.) Deposits Extent: **Light**
